Post-Cooldown August 2018 Assessment

2018
October

A cooldown of the Slifer Lab magnet was conducting at the end of August, 2018. Here follow some general thoughts.

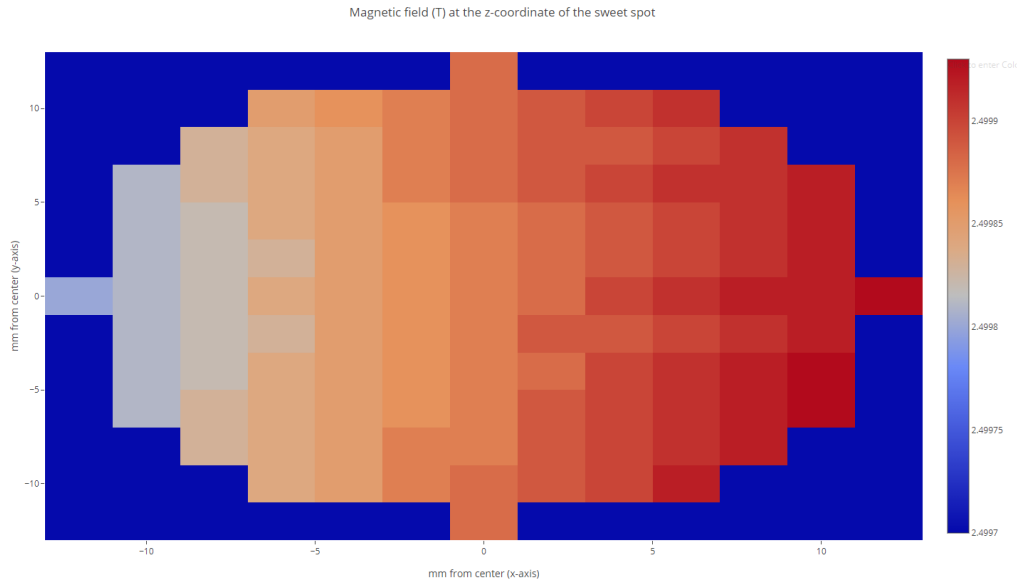
The sweet spot of the magnet was confirmed to be in almost exactly the spot it was predicted to be, 1225.5 millimeters down from the top of the magnet, or 330.5 millimeters down from the lower, inner lip of the thinnest cylinder inside the magnet, in the center of the column.

Figure 1: Magnetic field (T) at the z-coordinate of the sweet spot.

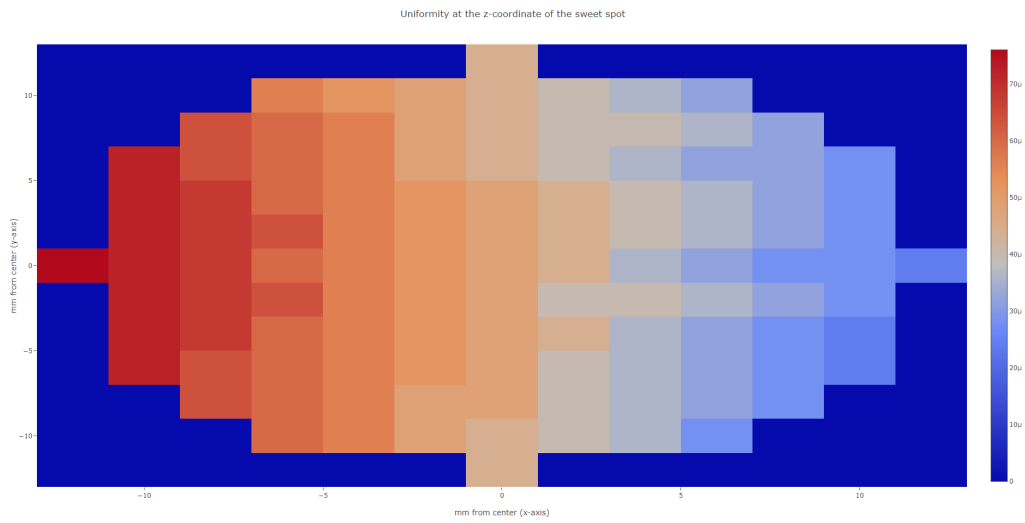
Figure 2: Uniformity at the z-coordinate of the sweet spot.

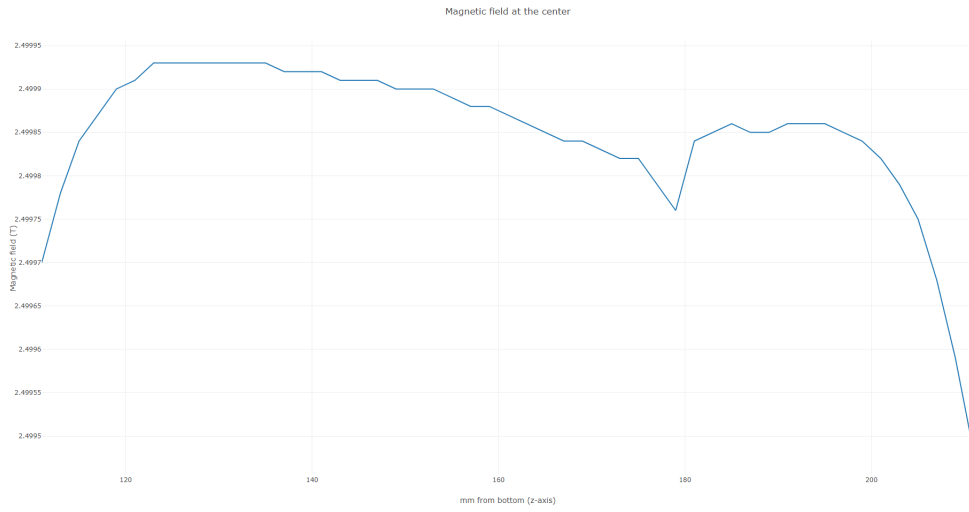
Figure 3: Magnetic field at center, along z-axis

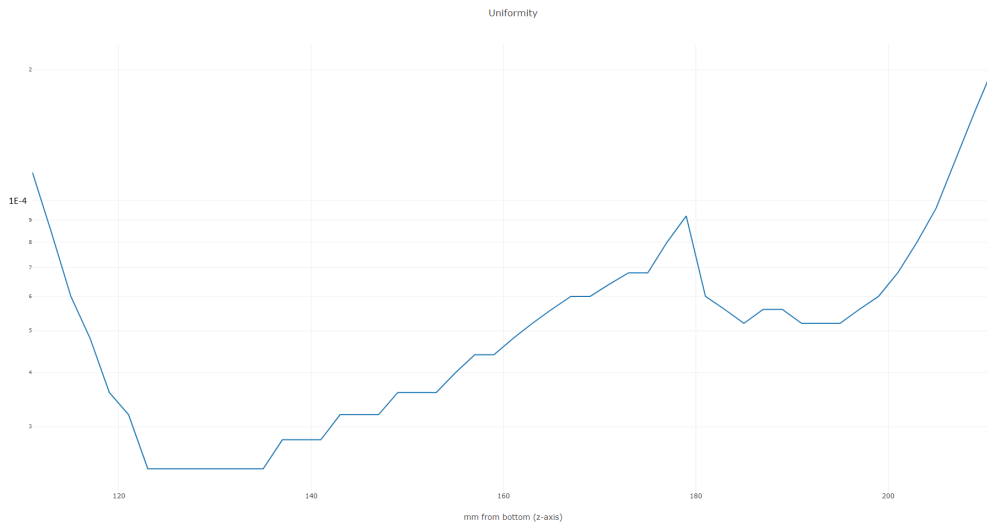
Figure 4: Uniformity at center, along z-axis

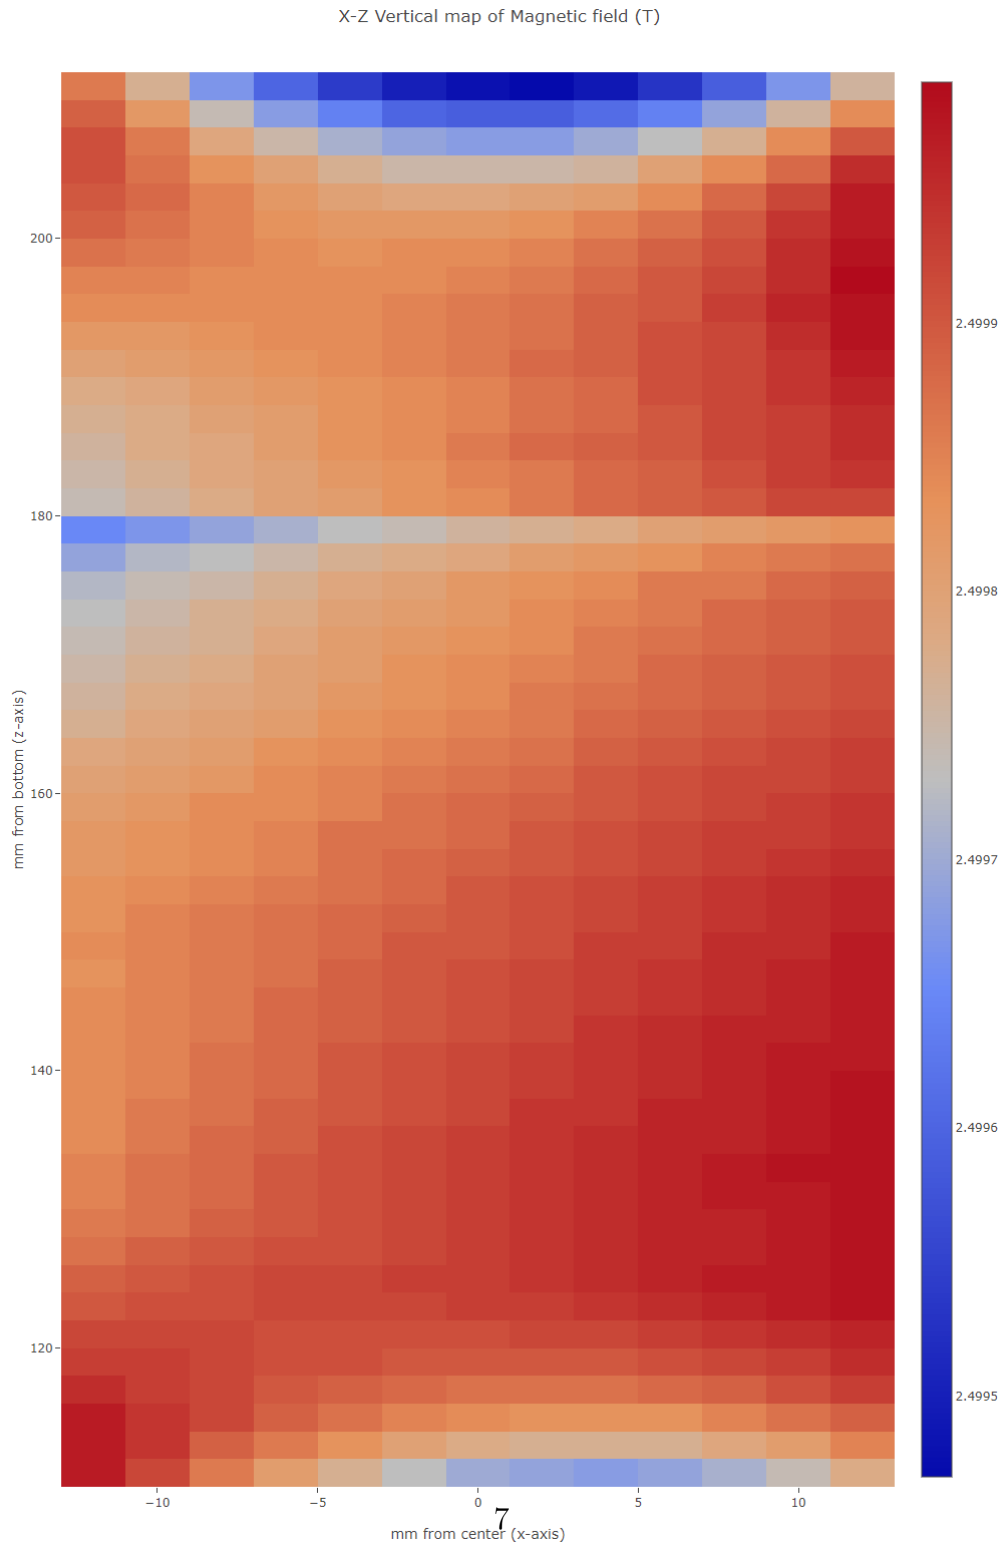
There was one hiccup: partway through the sweep, it had looked like the carbon fiber tube had cracked on the webcam being used to monitor the probe during the sweep, and the sweep was halted. However, upon close inspection, it was just a buildup of ice. The sweep was restarted, and completed, but this left a visible delineation on the finished map; the NLE actuators were realigned before the restart, which may have corrected for some possible drift prior to the stop, resulting in the odd look of the finished map.

Figure 5: X-Z vertical map of magnetic field.

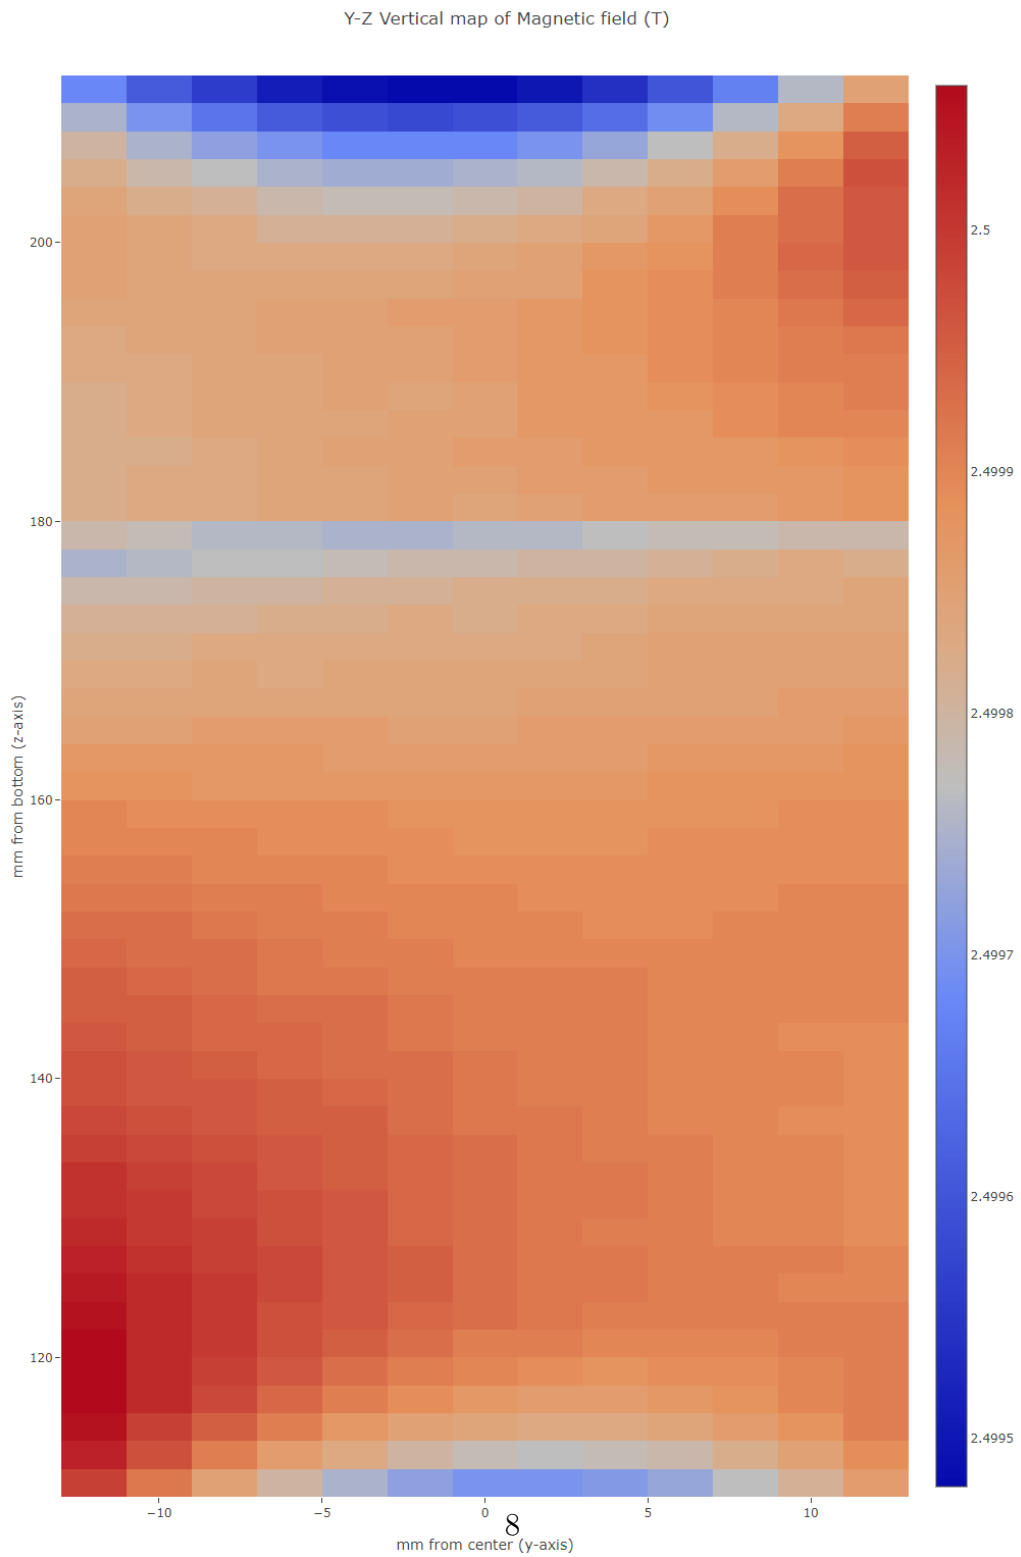
Figure 6: Y-Z vertical map of magnetic field.

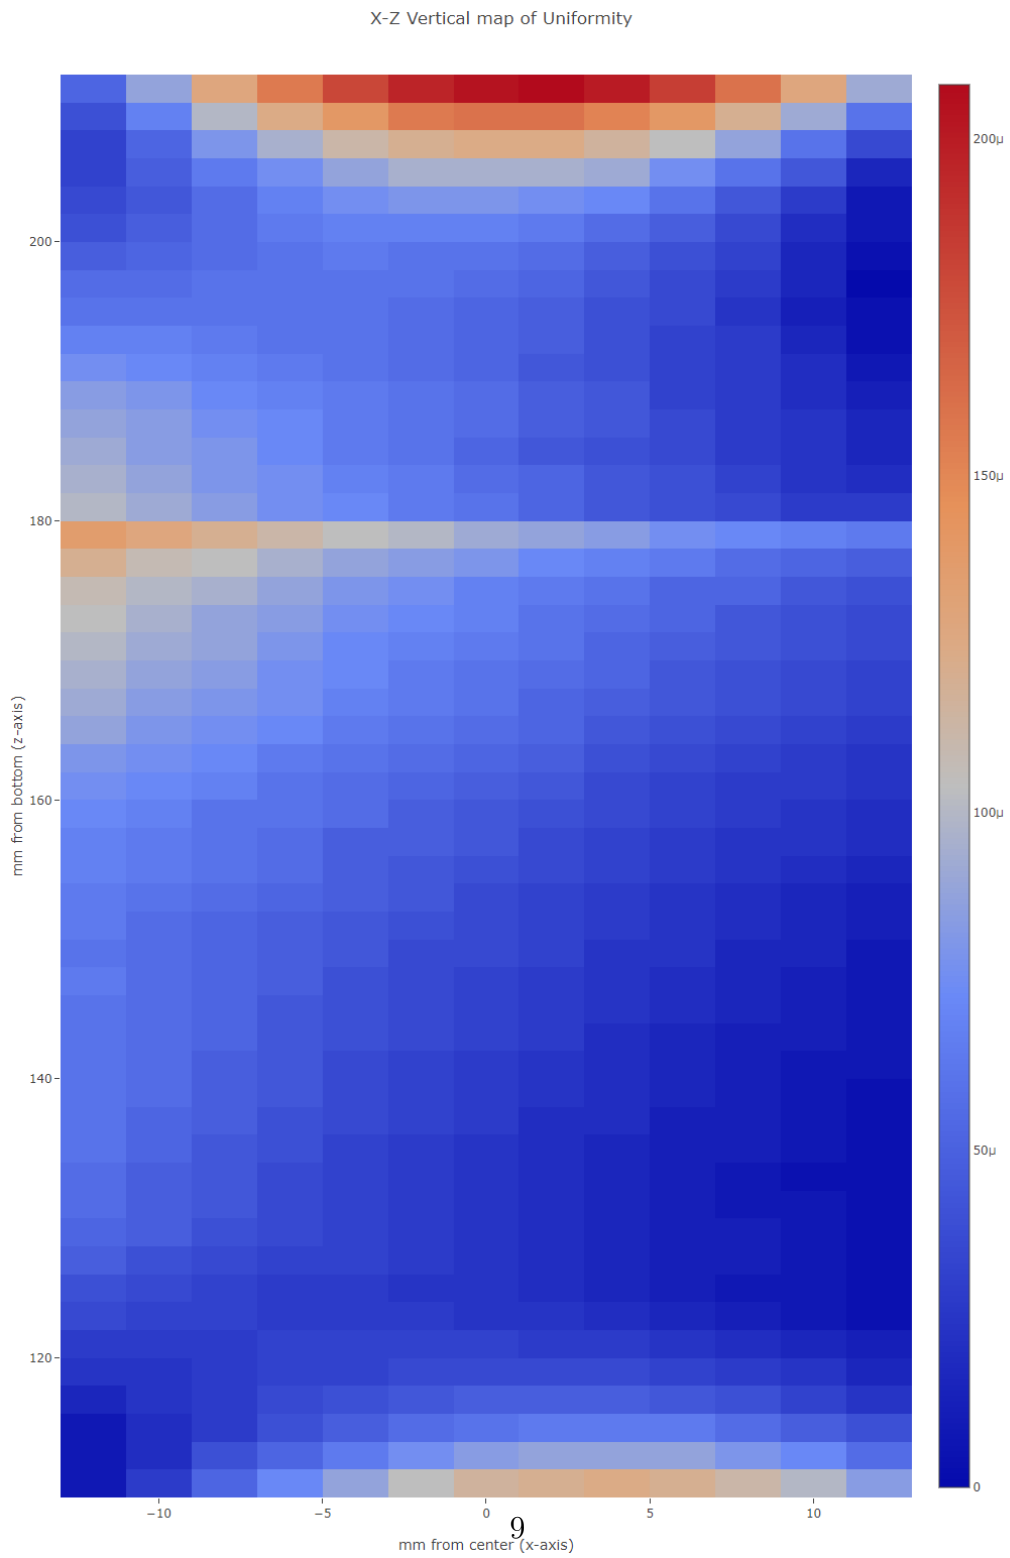
Figure 7: X-Z vertical map of uniformity.

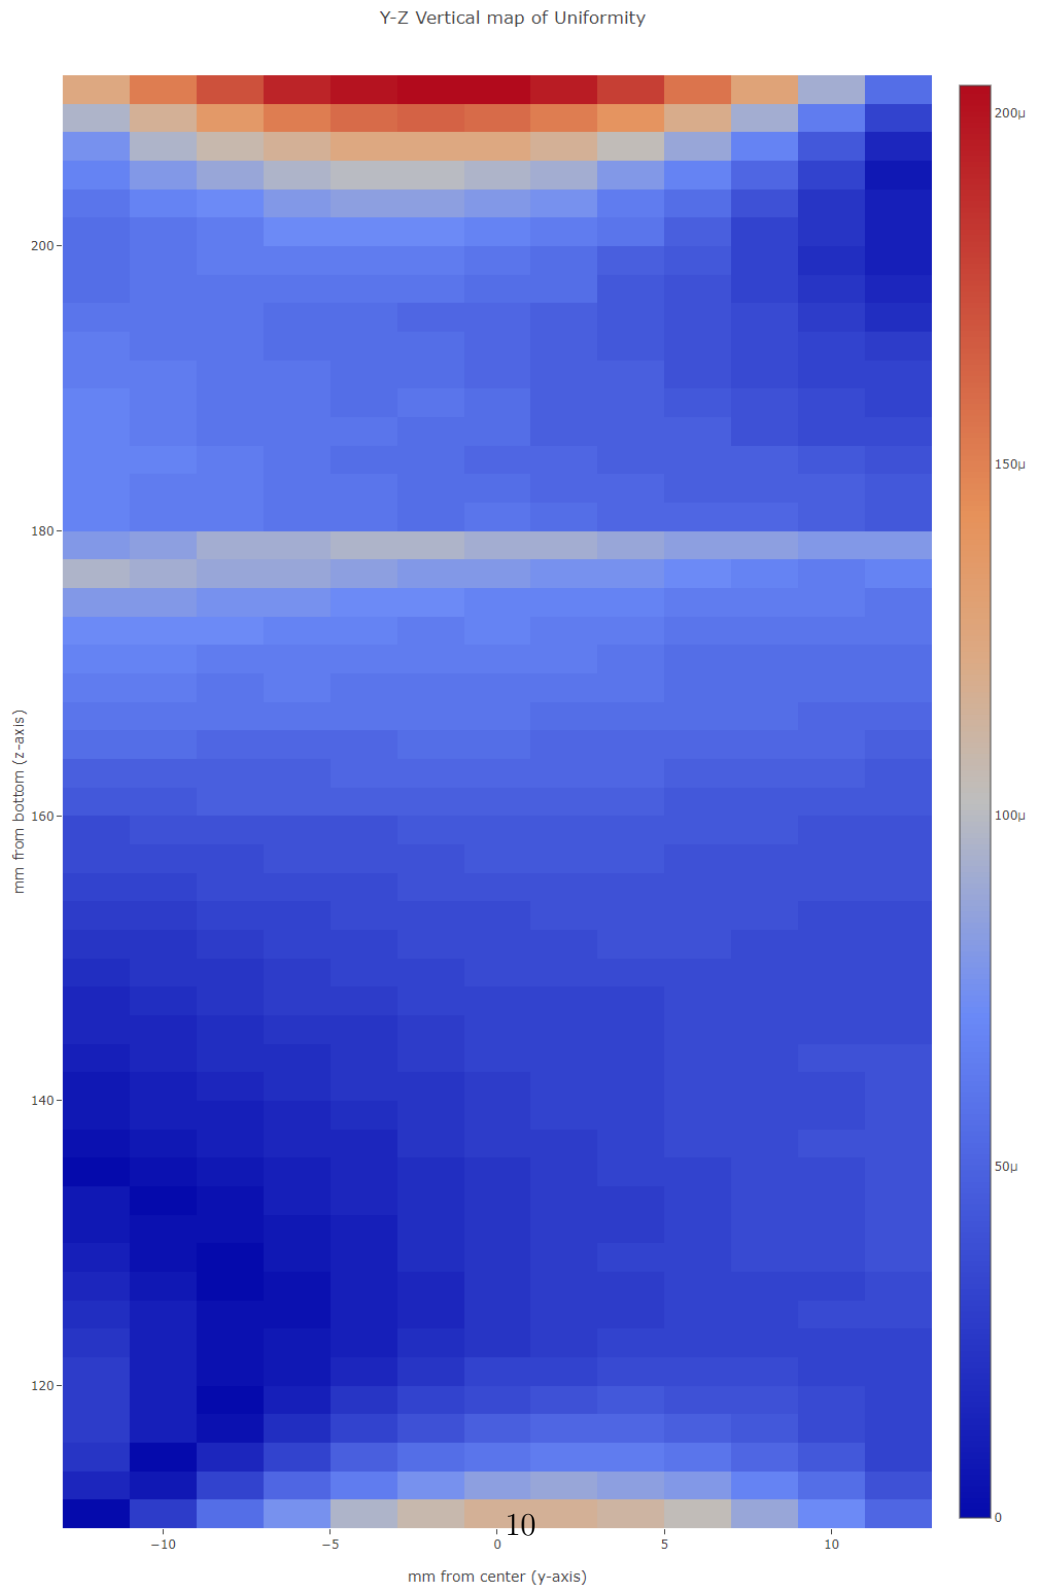
Figure 8: Y-Z vertical map of uniformity.
